Preliminary Information

PIT5605B Rattle Noise from 60 /40 Rear Seat

Models

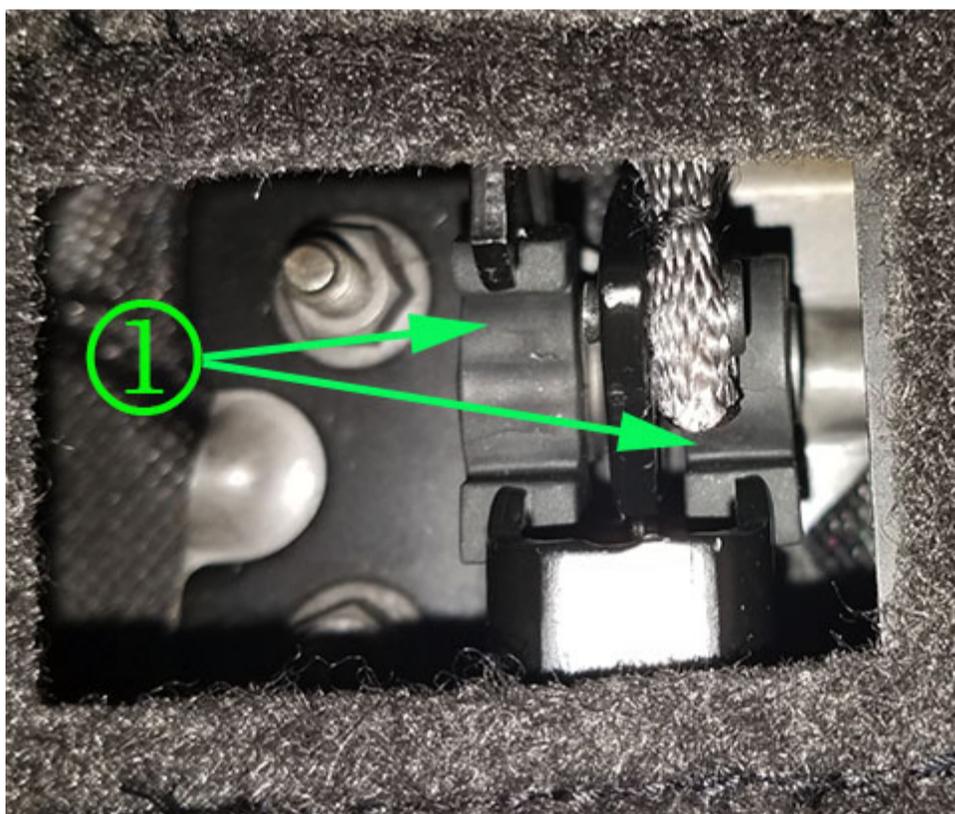
Inspect the alignment of the bumpers in the latch in relation to the striker. (Illustration 1 below.)

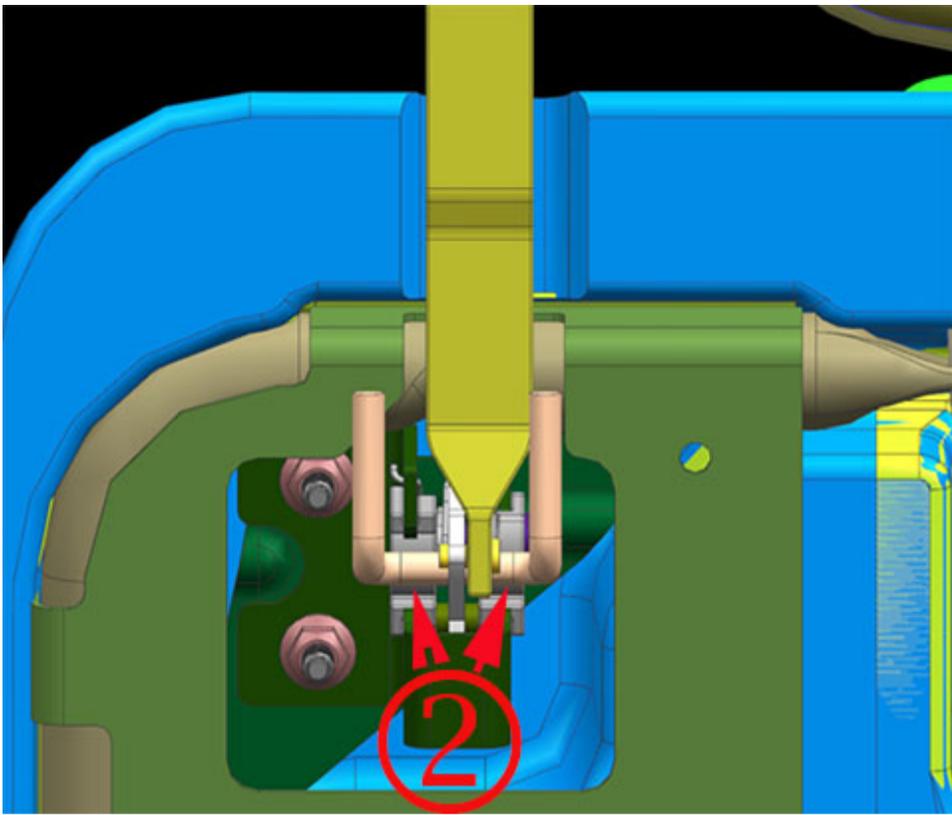
Illustration #2 below shows both bumpers engaged .

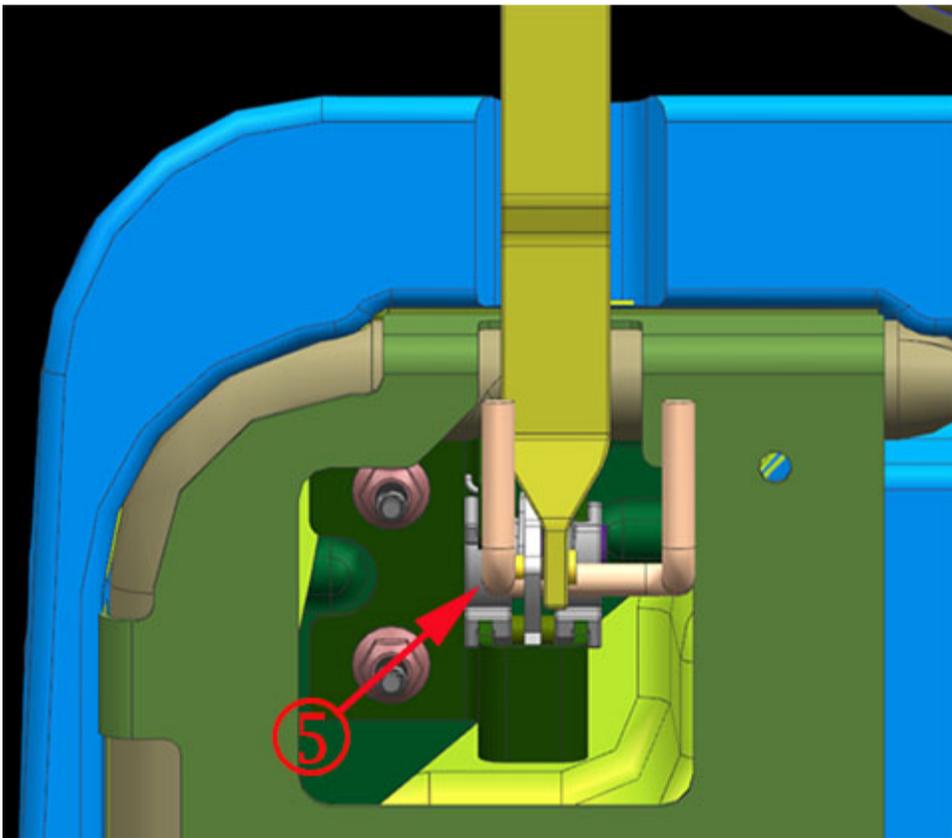
Illustration #3 shows the latch aligned too far right , only one bumper engaged.

To align the striker to the insulators , loosen the nuts on the studs left and right shown below and move the seat left or right until centered.

Once aligned retorque the nuts on the studs to 45 Nm (33 lbs ft) and verify repair.

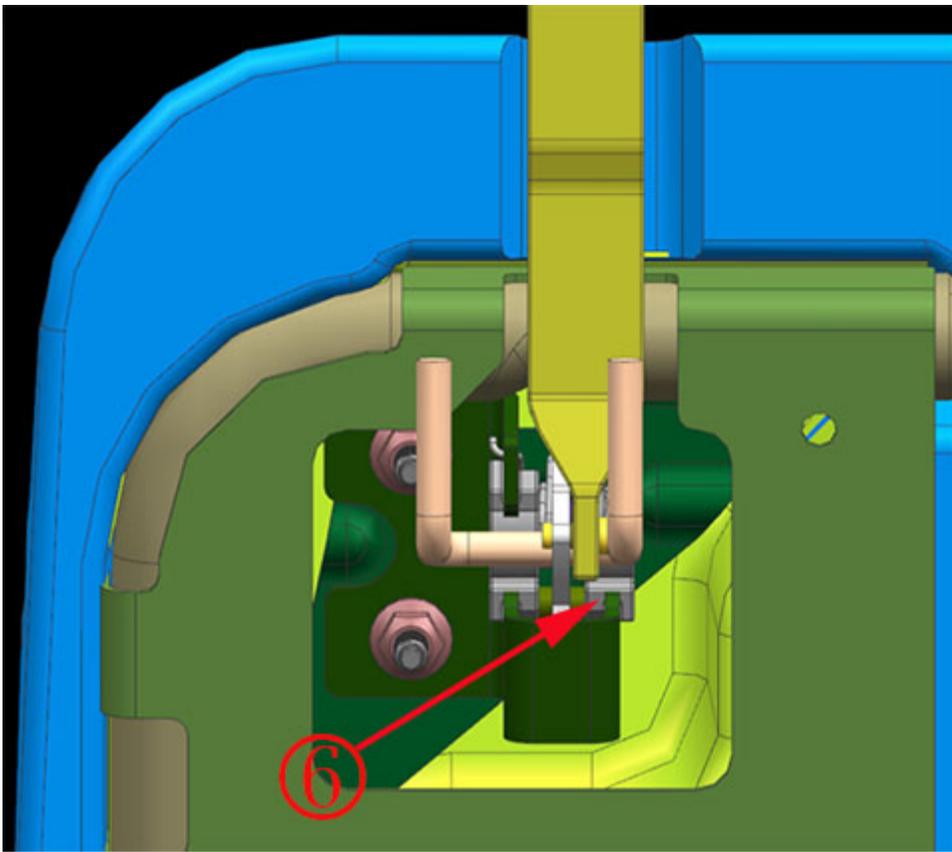
Illustration #4 shows latch aligned too far left , only one bumper engaged.
